**Date:** April 30, 2004

**Subject:** Advisory Concerning BSF Design and Installation Procedures – Cold

Weather Related Design Adjustments and Precautions

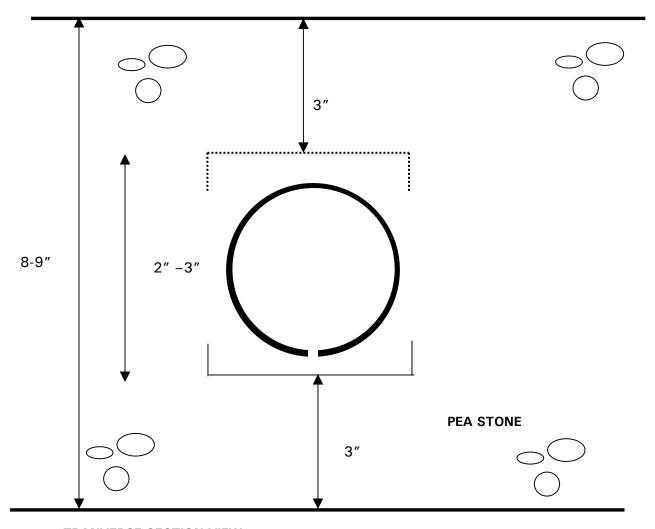
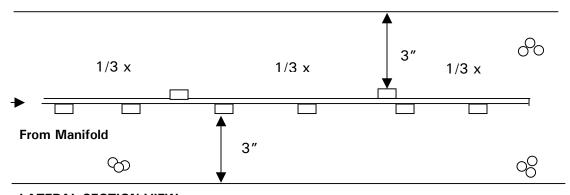
# FIGURE 8A - ORIFICE SHIELD & LATERAL DETAILS

Approximately thirty (30) instances of malfunctions of bottomless sand filter systems due to cold weather freeze-ups have been reported to the Department during the past winter months. The reports followed periods when outdoor nighttime temperatures fell below 10 degrees Fahrenheit for several consecutive days. Problems were varied but included frozen transport pipes, frozen laterals, and possibly frozen filter media due to poorly sorted stone containing fines. The majority of cold weather malfunctions reported involved BSFs preceded by a BioMicrobic FAST pre-treatment system. The Department and the vendor are currently collecting data and investigating the basis of this occurrence. Overall, the number of BSFs reporting freeze-up problems represents less than 5% of all installed BSFs.

A series of 1/8 inch diameter holes (orifices) shall be drilled in the distribution laterals and spaced no less than 14 inches and no more than 24 inches apart. Two (2) orifices in each lateral shall be drilled pointing up (12 o'clock position); all other orifices shall be drilled pointing down (6 o'clock position). The up-pointing orifices shall be located approximately 1/3 and 2/3, respectively, along the length of each lateral. Orifice shields shall be placed over each orifice (above or below the lateral, as required). Orifice shields placed below any orifice shall contain slots or holes to provide free draining (usually referred to as cold weather orifice shields). See Figure 8.

(f) After the required amount of filter sand has been added to the filter, place (3) inches of 3/8" washed pea stone over the filter sand. After the distribution laterals and orifice shields have been assembled atop the pea stone, add more pea stone so that a three (3) inch depth of pea stone is installed over the laterals and any upper orifice shield (See Figure 8A). The total depth of pea stone over the sand media will range from eight (8) to nine (9) inches, depending on the size of lateral pipe employed. No filter fabric of any kind should be placed between the sand and overlying pea stone.

Maintenance providers are encouraged to retrofit existing BSFs showing evidence of cold weather malfunctions. Retrofits may include drilling of upfacing orifices, addition of orifice shield, or placement of additional pea stone to achieve the required three (3) inch depth over the laterals may be made. Please note that any upfacing orifice drilled may require plugging of a downward facing orifice, in order to maintain proper pressures during dosing. A short, thick screw that does not penetrate the interior of the lateral may be used to plug these orifices. Transport lines that were installed improperly should be adjusted to prevent freezing. No RIDEM permit is required to make these maintenance adjustments. However, it is recommended that maintenance providers review any extensive retrofitting needs with the original designer and/or installer to ensure consistency with the original design.
